## NIHE HTC BSL-3 System Inspection Report

Background	NIHE Biosafety Dept. requested HTC BSL-3 facility inspection to JICA NIHE project. BioSafety Dept. provided system checklist (BSL3 NIHE System Checklist), and inspection was performed according to checklist.
Date	14 June 2021 - 17 June 2021
Member	Miki Hideki (JICA NIHE Project Expert) Le Tuyet Thanh (JICA NIHE project Interpreter) Nguyen Thanh Thuy (NIHE BioSafety Dept.) Trinh Thi Thanh Huong (NIHE BioSafety Dept.) Dao Hoang Anh (NIHE BioSafety Dept.) Trong Hai and others (NIHE Facility Dept.)
Purpose	To find serious items which have to be repaired or replaced immediately.
Result	Serious item is not found. But some spare parts have to be prepared and some equipments have to repaired or replaced.

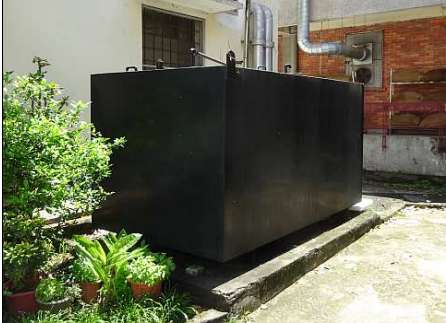
Sign	Equipment	Location	Pcs	Check	Comment
FOT	Fuel Oil Tank

Energy Plant (outside)	1	No leakage, rust.	OK.
FST	Fuel Oil Service Tank	Energy Plant	1	It cannot be found. FST may be included in FOT.	<b>Drawing has to be revised.</b>
OPG	Oil Transfer Pump	Energy Plant	2	It cannot be found. OPG may be included in BO.	<b>Drawing has to be revised.</b>
BO	Steam Boiler

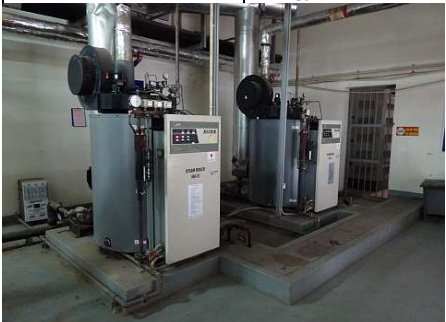
Energy Plant	2	No abnormal heat, sound, vibration. Water supply pump of No.2 was repaired by manufacturer engineer.	OK.
SSH	Steam Header

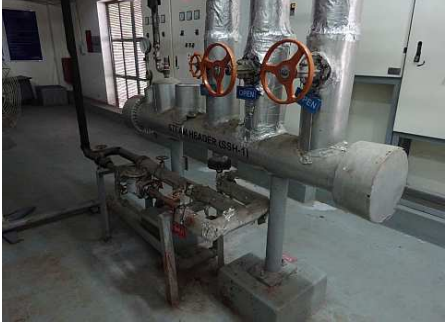
Energy Plant	1	No leakage, rust.	OK.
SCR	Steam condensate Receiver

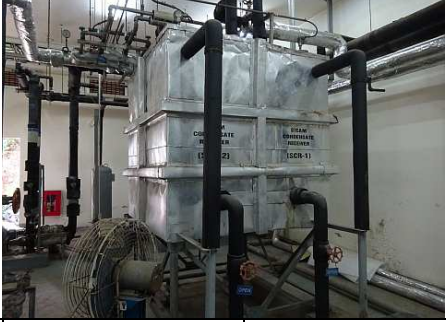
Energy Plant	2	No leakage. Tank is made by carbon steel plate, inside has rust.	Stopping rust method is, 1. To stop system and cool down. 2. To blow water. 3. To polish inside. 4. To paint heat resistant paint. <b>!Pay attention strongly to steam inflow and O2 shortage.</b>
WS	Water Softener

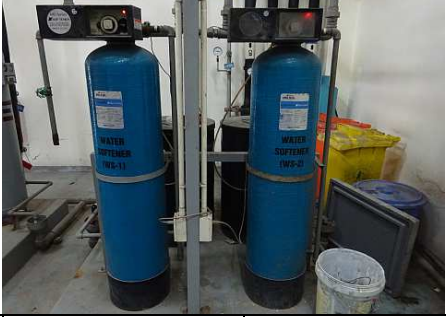
Energy Plant	2	Water softener needs maintenance to supply chemical (salt) regularly, and maintenance is performed once per week, but maintenance document is not found.	OK. Maintenance document has to be saved, even if maintenance is well done.

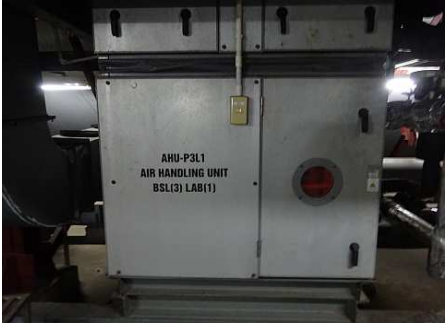
Sign	Equipment	Location	Pcs	Check	Comment
AHU P3L1	Air Handling Unit for Lab1

HTC (4F)	1	No abnormal heat, sound, vibration. Coil is clean. Steam trap was maintained. PD: Filter pressure difference = 160Pa TS: Supply chilled water temp. = 12 degree C TR: Return chilled water temp. = 18 degree C	OK. But TS and TR have to be checked.
AHU P3L2	Air Handling Unit for Lab2

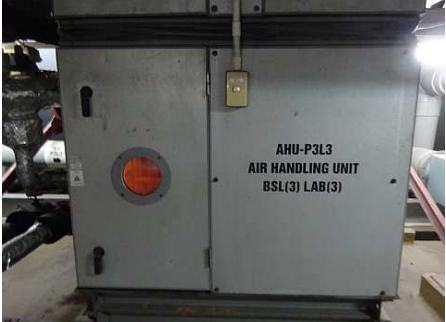
HTC	1	No abnormal heat, sound, vibration. Coil is clean. Steam trap was maintained. PD= 150Pa TS= 14 degree C TR= 16 degree C Steam leakage because of control valve, but it is repaired soon.	OK. But TS and TR have to be checked.
AHU P3L4	Air Handling Unit for Lab4

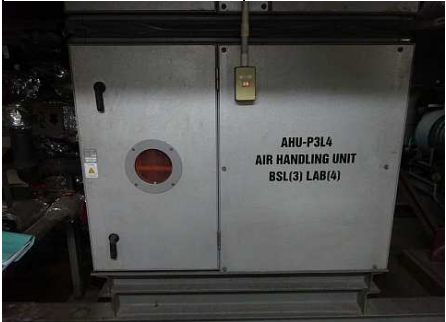
HTC (4F)	1	No abnormal heat, sound, vibration. Coil is clean. Filter pressure gauge does not work well, tube may be disconnected, but not serious problem. TS= 14 degree C TR= 16 degree C	OK. But TS and TR have to be checked.

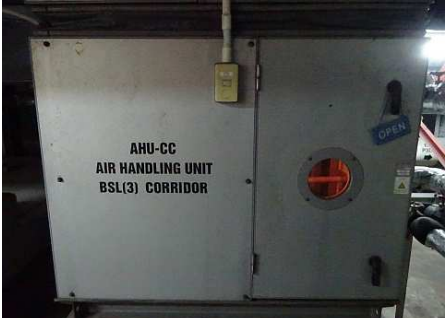
AHU CC	Air Handling Unit for Corridor

HTC (4F)	1	No abnormal heat, sound, vibration. Coil is clean. Steam trap was maintained. PD= 70Pa TS= 14 degree C TR= 17 degree C	OK. But TS and TR have to be checked.

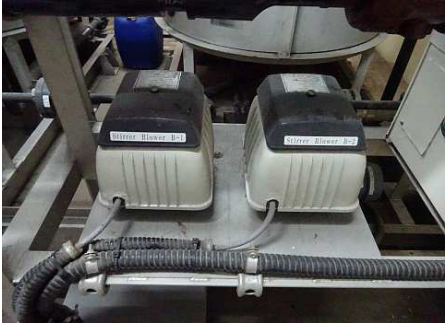
<p>- Waste Water Treatment system/ Supply fan</p>

<p>HTC (BF)</p>	<p>2 No abnormal heat, sound, vibration.</p>	<p>OK.</p>
<p>- Waste Water Treatment system/ Supply air filter</p>

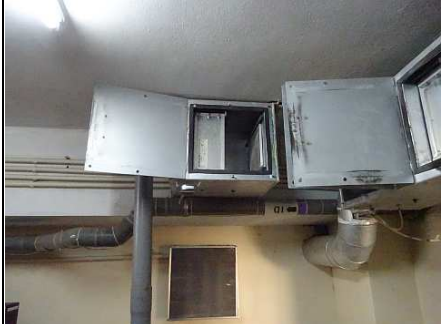
<p>HTC (BF)</p>	<p>1 Not dirty.</p>	<p>OK.</p>
<p>- Waste Water Treatment system/ Supply air heater</p>

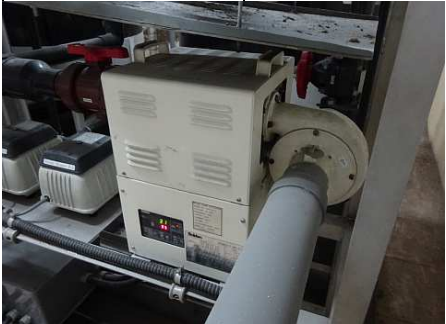
<p>HTC (BF)</p>	<p>1 No abnormal heat, sound, vibration. Including own fan.</p>	<p>OK. Exhaust heater has function to dehumidify exhaust air in order to prevent exhaust air filter from being filled by moisture.</p>
<p>- Waste Water Treatment system/ Exhaust air filter</p>

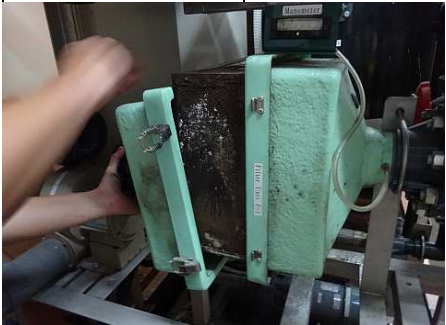
<p>HTC (BF)</p>	<p>1 HEPA filter and Pre filter in casing are damaged by water.</p>	<p><b>Filters have to be replaced, and casing has to be dried and cleaned.</b></p>
<p>- Waste Water Treatment system/ Exhaust air fan</p>

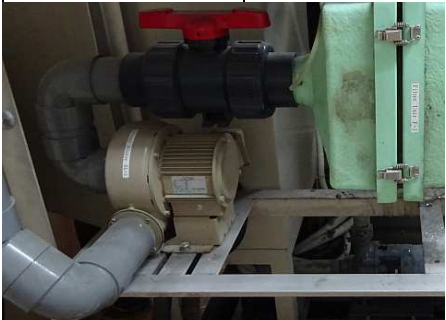
<p>HTC (BF)</p>	<p>1 No abnormal heat, sound, vibration.</p>	<p>OK.</p>

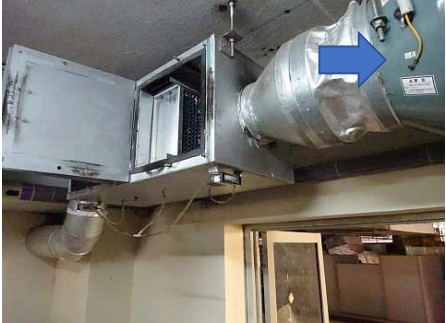
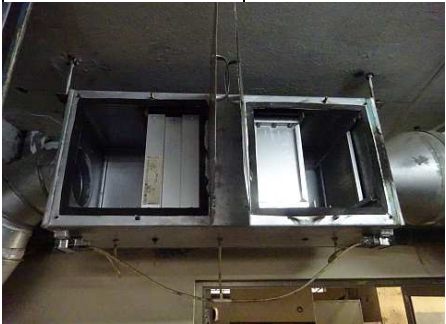
-	Waste Water Treatment Room/ Exhaust fan	HTC (BF)	1 No abnormal heat, sound, vibration.	OK. Room ventilation system is not included in drawing. Drawing have to be added.
-	Waste Water Treatment Room/ Exhaust filter	HTC (BF)	1 Not dirty.	OK.

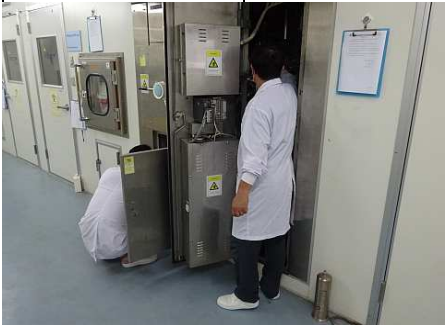
-	Autoclave 2 doors	HTC (3F)

4 User's manual is not found. Maintenance is performed without manual. But manual can show more detail information.	Manual have to be prepared. Autoclave model type is Sakura FLD-B09WP3T. Soon manual, drawing, parts list was provided by Sakura, although Japanese language version.
-	BMS Monitoring	HTC (3F)

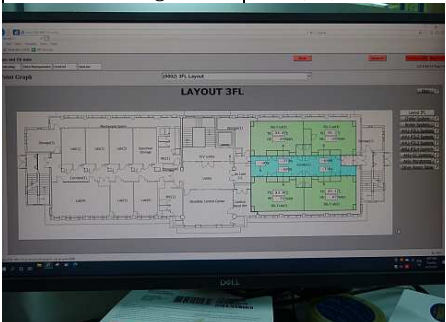
1 Air conditioning equipments and their parameters in HTC are shown on display, and parameters can be changed and stored on display. It is very convenient.	Equipments in energy plant and waste water treatment room are not included. All equipments had better to be included, however its cost may be expensive.
-	Electric cabinet	HTC, Energy Plant

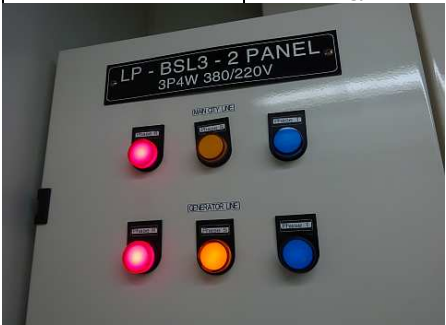
10 or more Some lumps on electric cabinet is not working. But not serious problem.	Lumps have to be replaced. It is better to install LED type, if possible. LED life is said as 40000hrs (4.5 years).
